Engineers mull cause of collapse

Written by Taipei Times

Wednesday, 02 October 2019 05:34 -

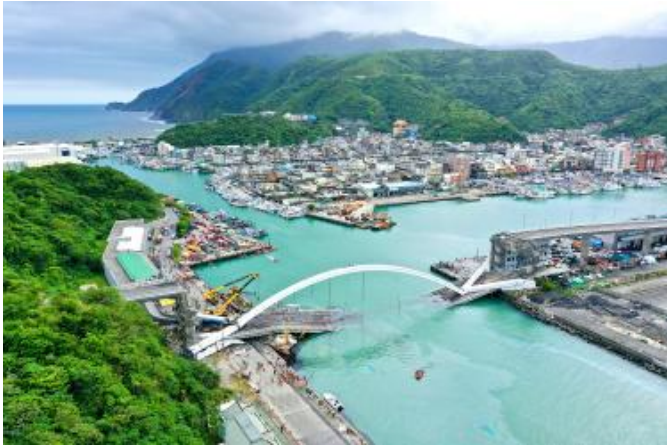
The Nanfangao Bridge in Yilan County's Suao Township is pictured after the bridge collapsed yesterday morning.
